DAMAGE IN HISTORIC RAMMED EARTH STRUCTURES: A CASE STUDY AT AMBEL, ZARAGOZA, SPAIN

This paper examines the possible causes of damage to historic rammed earth structures based on a case study of a medieval and later building, formerly a preceptory of the Military Orders, in the village of Ambel in Aragon, north-east Spain. Structural and water-based mechanisms of damage are reviewed and an engineering basis for the cause of damage is proposed. Since a number of repair strategies have already been attempted on this structure, their effectiveness is also discussed. A four storey granary at the north-east corner of the preceptory complex is described in detail since it encapsulates many damage mechanisms and repair strategies which are common to historic rammed earth. The granary tower has a random rubble foundation, which is probably in part the remains of previous building, with rammed earth walls for the three storeys above. This rammed earth was originally rendered and scored to imitate fired brick but almost all of this has now fallen away. The gable end of the building has fired brick quoins, and now leans outwards slightly at the head of the wall. There is evidence of water dam

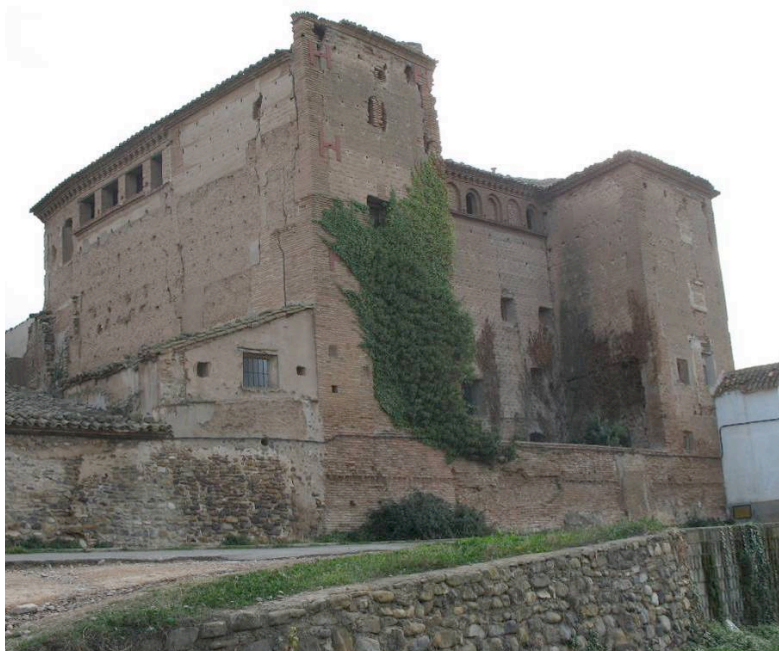
Today there are two independent sets of cracks in the east elevation (Fig. 1) – two slightly inclined cracks in the centre of the building; and two vertical cracks at the north end of the east elevation, which are related to the lean of the north gable end wall. This wall leans outwards from ground level to mid-height of the second storey, with the section above this being built vertically on top of a leaning wall. The current owners of the building installed crack monitoring points in the early 1990s and this monitoring shows the continued opening of the cracks at the northern end of the tower. As a result,

Fig. 1. The preceptory at Ambel, north-east elevation. The gallery of arches between the towers is typical of 16th century architecture in this region. The first phase precinct wall reaches the base of ivy and stands 3m high.

shows that there is no structural tie between the between the two. Any structural movement therefore results in an opening of the joint. This is particularly a problem in later medieval architecture, where brick quoins are used, and structural movement (for example of the gable end of a structure) is unrestrained and leads to an opening of the joint. An example of this can be seen on Fig. 1 immediately below the eaves at the northern end of the tower.

Where water has been allowed to gather and run down the face of a wall, cast structures, such as described in Section 4.1, are observed on the face of the wall (Fig. 5). However, these have served as a forewarning of further damage and caused the building owners to undertake repairs. As a result, there are no deep incisions into the rammed earth as shown in Fig. 4, and as observed at other historic rammed earth sites (Jaquin, 2008b). However, the eaves do not protrude on any of the faces, and this may have allowed a water flow down the face of the wall. If water is allowed to gather behind the render, then the rammed earth may become locally saturated, meaning the liquid bridges providing a bond between the render coat and the rammed earth may become saturated, causing the render to spall away from the wall (Fig. 1).

tie bars were placed at ceiling level at the ground, first and second storeys in 2000. These are fixed internally by bolting onto the ceiling beams and protrude externally to link to H-shaped bars on the facade which were positioned so as to overlap the brick quoins (Fig. 1).
